**Carquinez Straits Project
Maritime Archaeology**

**Report of Two Remnant Wharf Features
East of the Benicia-Martinez Bridge**

**Prepared by:
William Self Associates
Orinda, California
July 2000**

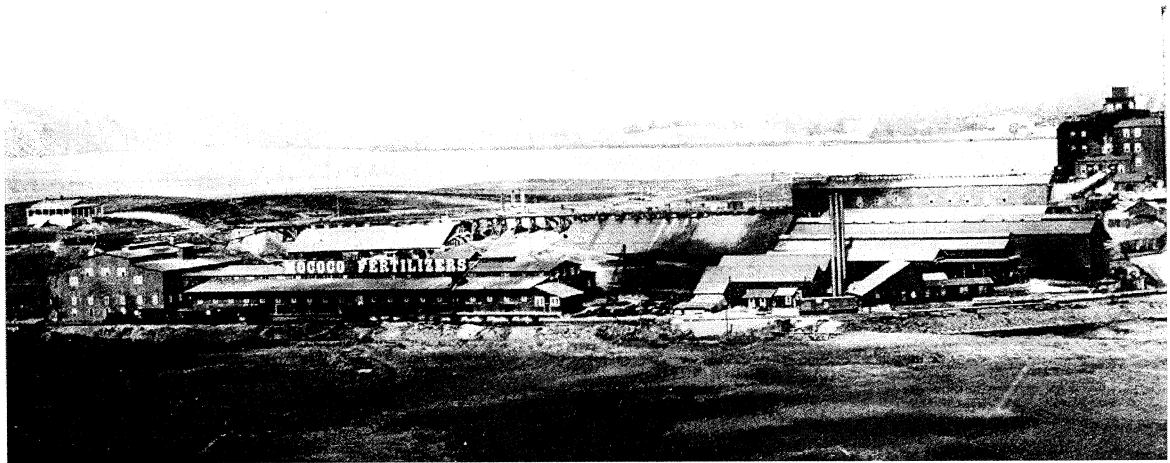
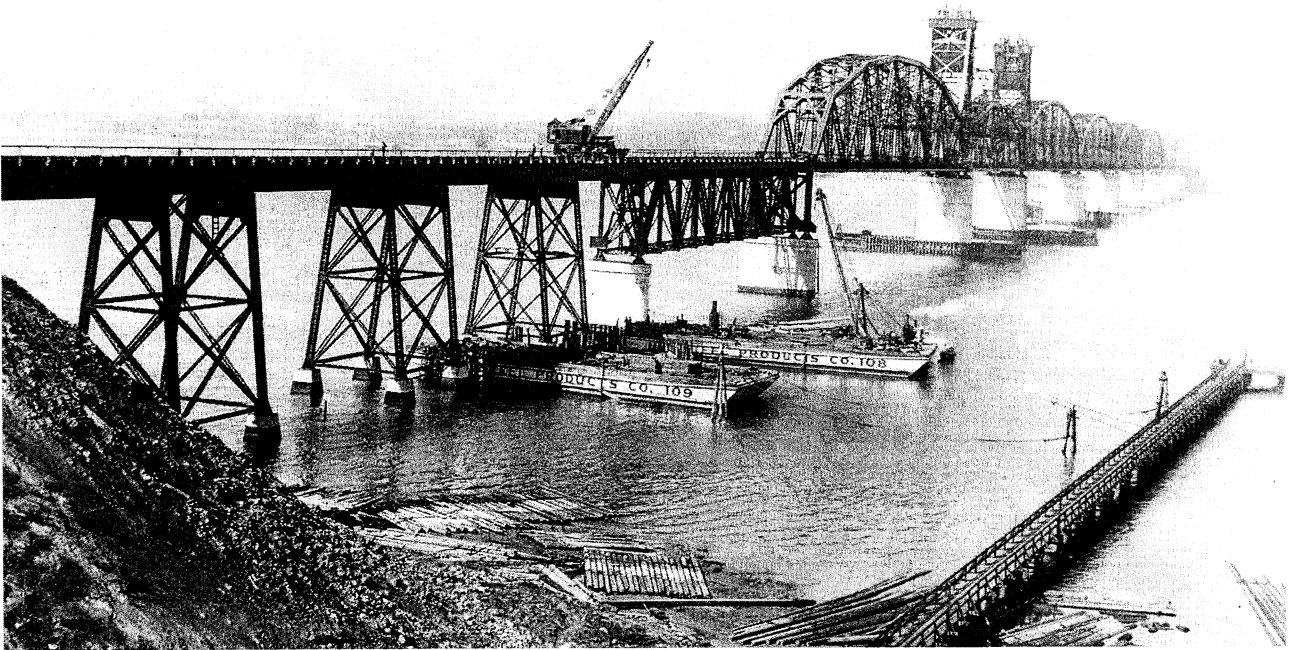
Photos 1 and 2

Mountain Copper Company ca. 1909 (Perry 1986: 26)

Mountain Copper Company Wharf ca. 1930 (Tatum 1993:23)

The remains of the western feature comprise the piles and a remnant of the wharf built by the Mountain Copper Company (MoCoCo), formerly located on the property now owned by Rhodia, Inc. (Photos 1 and 2). The wharf's remains lie 250 to 300 feet east of the railroad bridge and comprise two distinct sections. The southern section is the remains of a projecting pier, and the northern section appears to be the piles remaining from the perpendicular pier that once formed its head. No evidence of the pier or its supporting piles was evident on the shoreline itself. From the shoreline, 16 wood piles, each approximately 13 inches in diameter, extend for a distance of approximately 160 feet along a 340 degree azimuth (Photo 3). The crossheads and all supporting structural members are missing from the first 10 piles. Of those piles, six are aligned in pairs and four appear to be the remaining pile of what was once a pair. Two of these single piles are broken off at the waterline and are nearly submerged (Figure 1). The end of the southern section consists of a pair of piles, separated by a distance of 28 feet. Each pair comprises three individual piles, two of which are situated side-by-side on the eastern side (refer to Photo 3). A crosshead supporting two parallel joists spans the width of each pair. The joists, in turn, provide support for the remains of the wharf surface itself, consisting of 20 wood planks, aligned perpendicular to the joists and parallel to the crossheads (Photo 4).

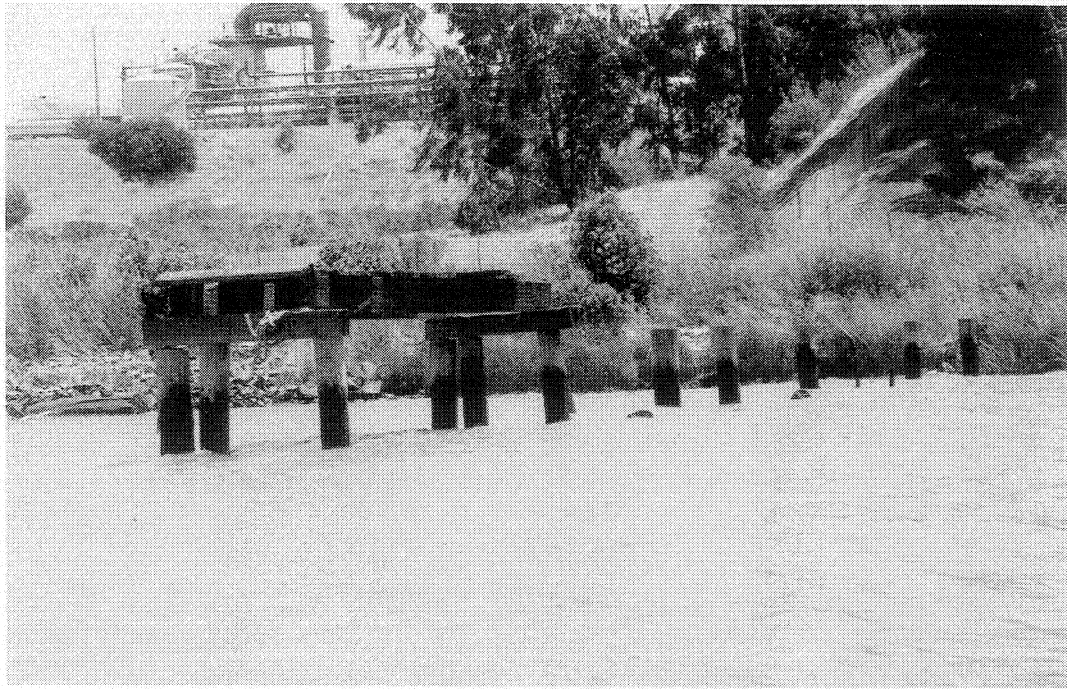
Photo 3: Southern Section of West Wharf Feature (MoCoCo Wharf), View Southeast

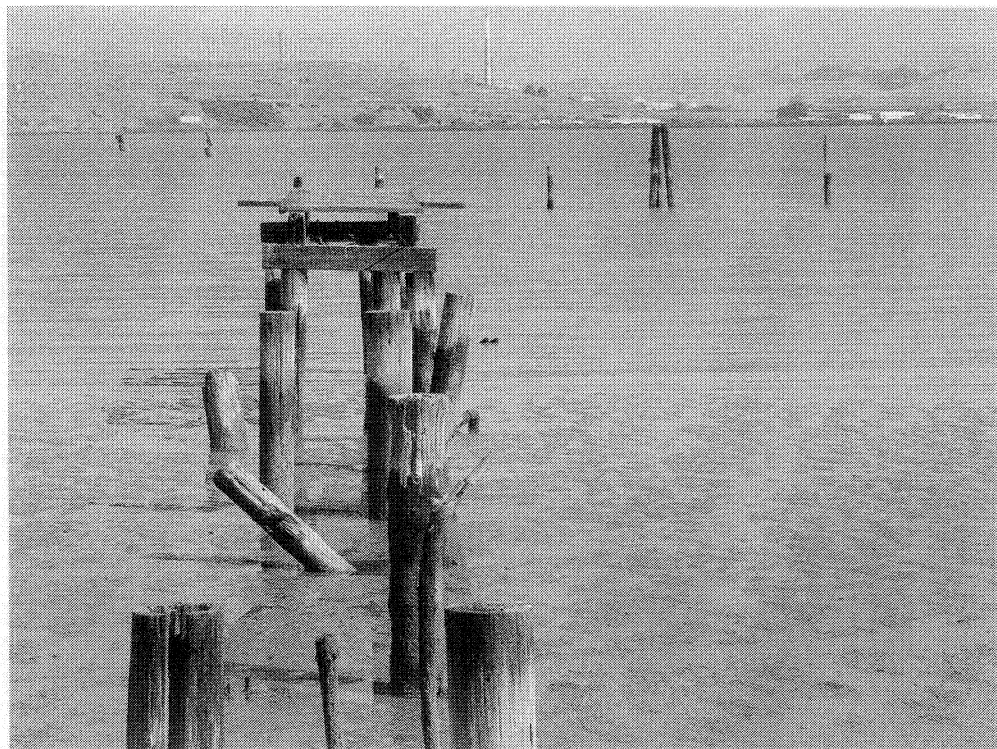
Photo 4: Southern Section of West Wharf Feature (MoCoCo Wharf), View North

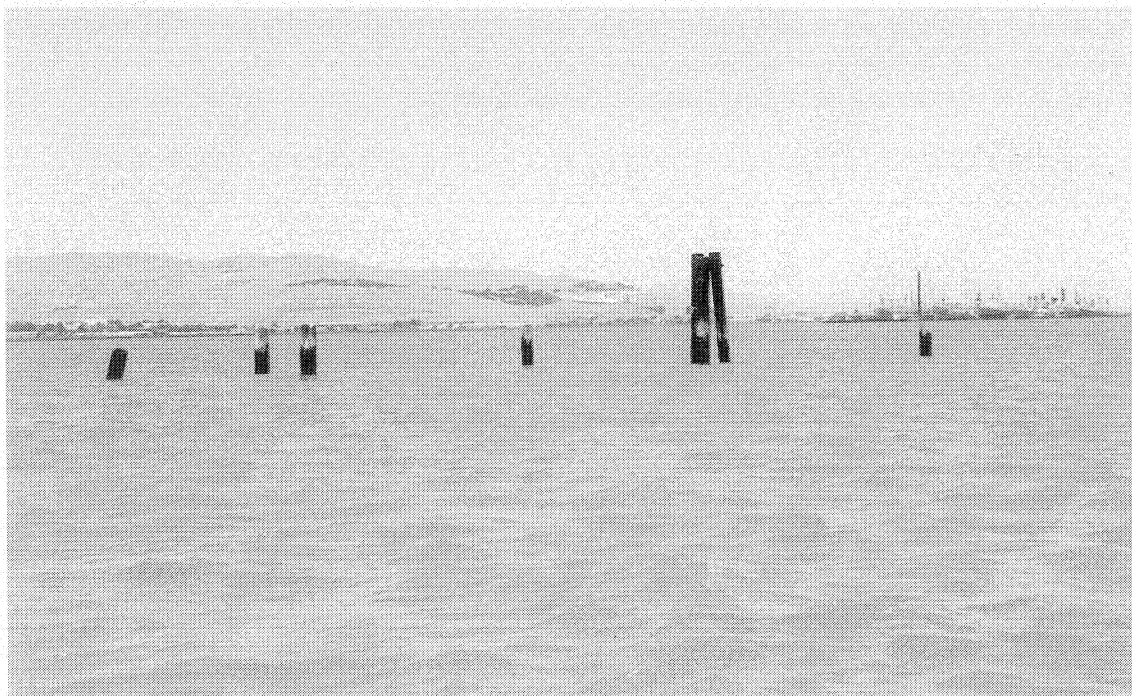
Photo 5: North Section of MoCoCo Wharf. View North

The northern section of the feature is situated approximately 270 feet north of the wharf remnant. It is aligned along an azimuth of 68 degrees and comprises eight pilings, three of which are individual piles that appear to be the remains of a pair, one pair of piles, and three piles clustered together to form what once may have been a dolphin¹ (Photo 5). No crossheads or supporting structural members remain on the northern portion of the feature.

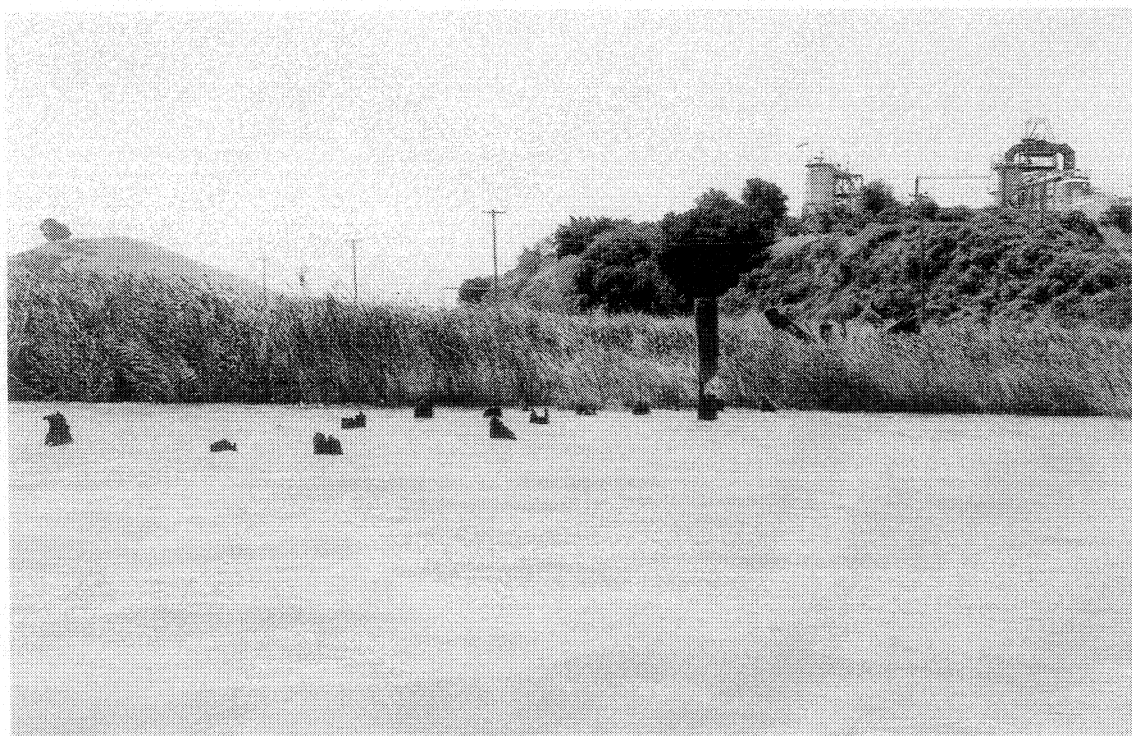
Photo 6: Southern Portion of Eastern Wharf Feature. View Southeast

The southern section of the feature, that part in the water closest to shore, comprises 16 piles, all but one of which are broken off at the waterline and nearly submerged (Photo 6). The piles are arranged in five sets that are separated from each other by approximately 15 feet. Three piles form each of four sets; four piles form the fifth set. The piles in each set are aligned side-by-side along an east-west axis. No crossheads or supporting structural members are visible above the waterline. The entire southern portion of the feature projects from the shoreline approximately 60 feet along an azimuth of 10 degrees.

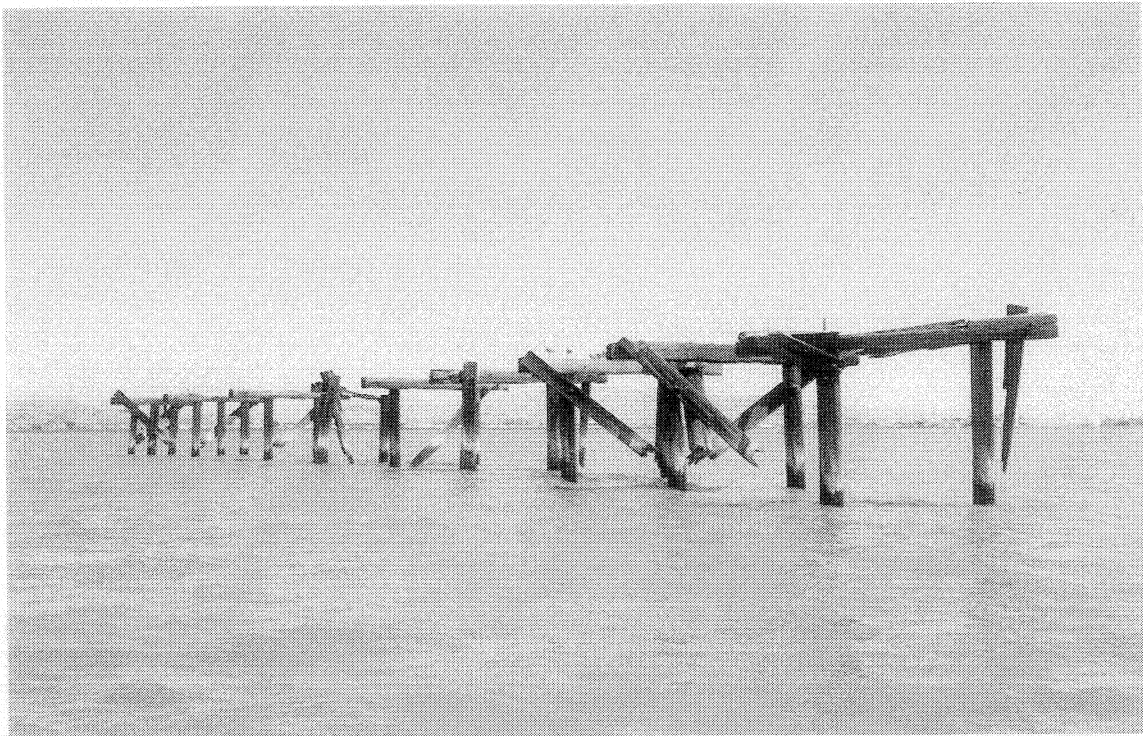
Photo 7: Central Portion of Eastern Wharf Feature. View Northeast

The central section of the feature is approximately 120 feet long and curves some 20 degrees along a gentle arc to the northwest. It comprises nine sets of 13 inch diameter wood pilings, all of which retain their horizontal cross heads and most of which still have remnants of their cross-supports still attached (Photos 7 & 8, and Figure 4). The piles forming each set are spaced on centers of approximately 6.5 feet, and the sets are separated from each other by distances ranging from 14 feet 9 inches to 15 feet 2 inches. The remnant of a single joist spans the distance between the second and third pile sets, and another spans the distance between the third and fourth set. Unlike the other seven pile sets in the central section, three piles form the last two sets, although the overall width of these sets is the same as that of the other seven.

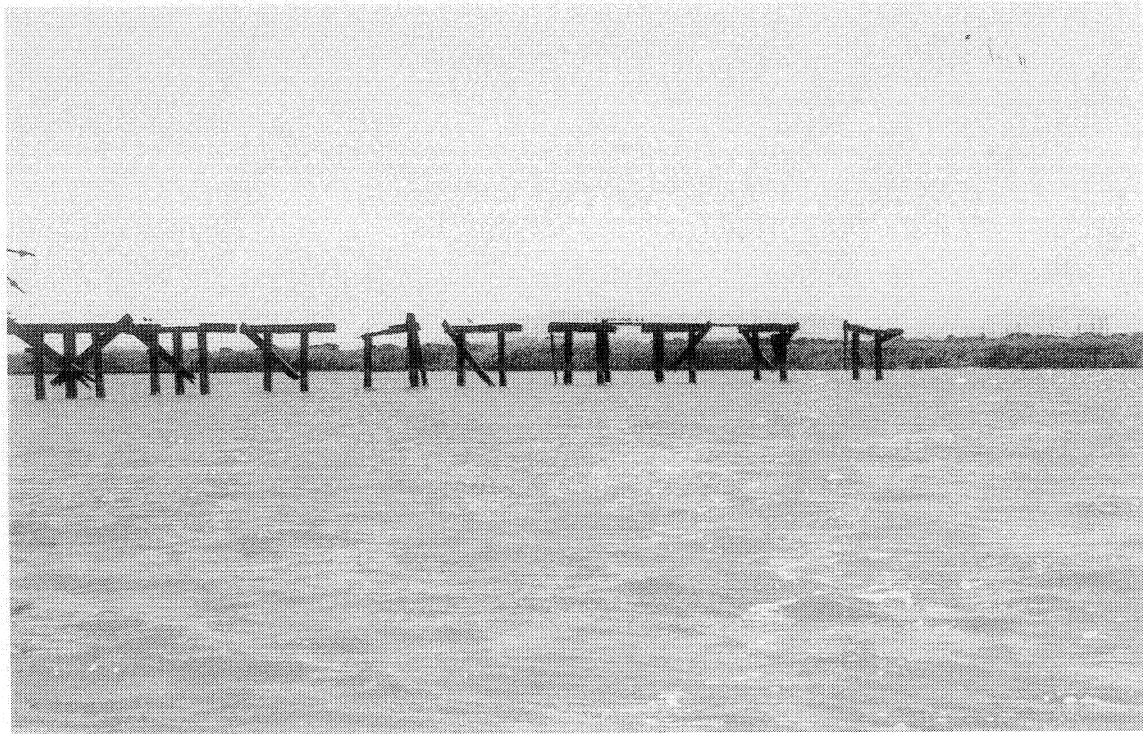
Photo 8: Central Portion of Eastern Wharf Feature. View Southeast

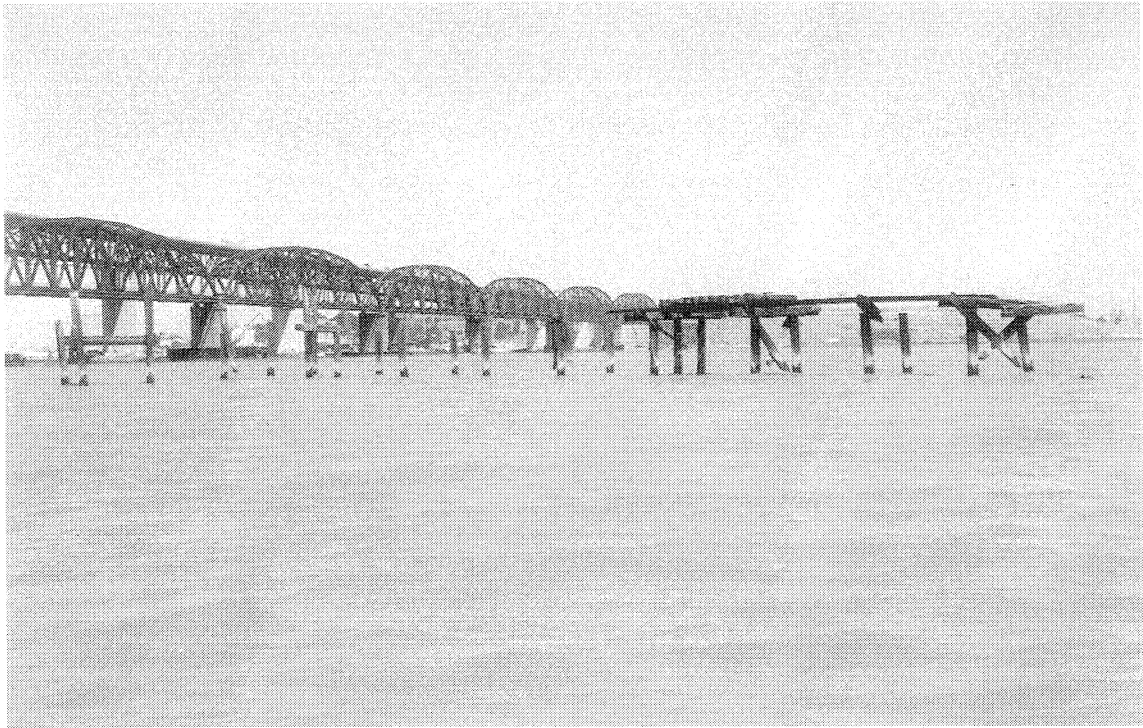
Photo 9: Western (terminal) Portion of Eastern Wharf Feature. View North

The western section, forming the end of the feature, begins approximately 50 feet west of the end of the central section. Twenty-six wood piles, each approximately 13 inches in diameter comprise this portion of the feature (Photos 9 & 10). A single wood pile,

broken at the waterline and nearly submerged marks the beginning of this section. The remaining 25 piles are arranged in sets. Nine of these form a gentle curve that is aligned nearly due west. Like the central section, the piles in each set are spaced on centers of 6.5 feet, and distances of approximately 15 feet separate the sets from each other. Seven of the pile sets are formed by pairs of wood piles, two sets are formed of three evenly-spaced piles, and one pile appears to be the remains of what once was a pair. Five of the pile sets retain their crossheads and a single joist spans the distance between the first four pairs, running along the south side of each. Between the third and fourth of these sets, two more joists span the north side and support the fragmentary remains of the wharf's wood-plank surface.

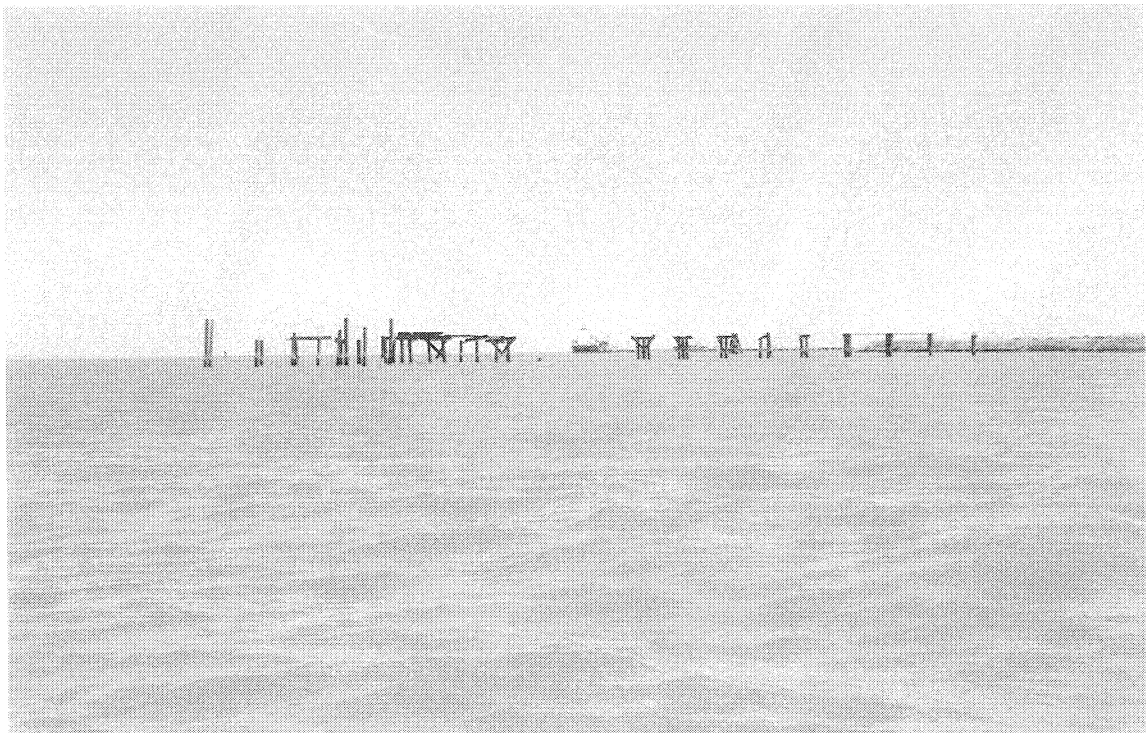
Photo 10: Western and Central Portion of Eastern Wharf Feature. View West

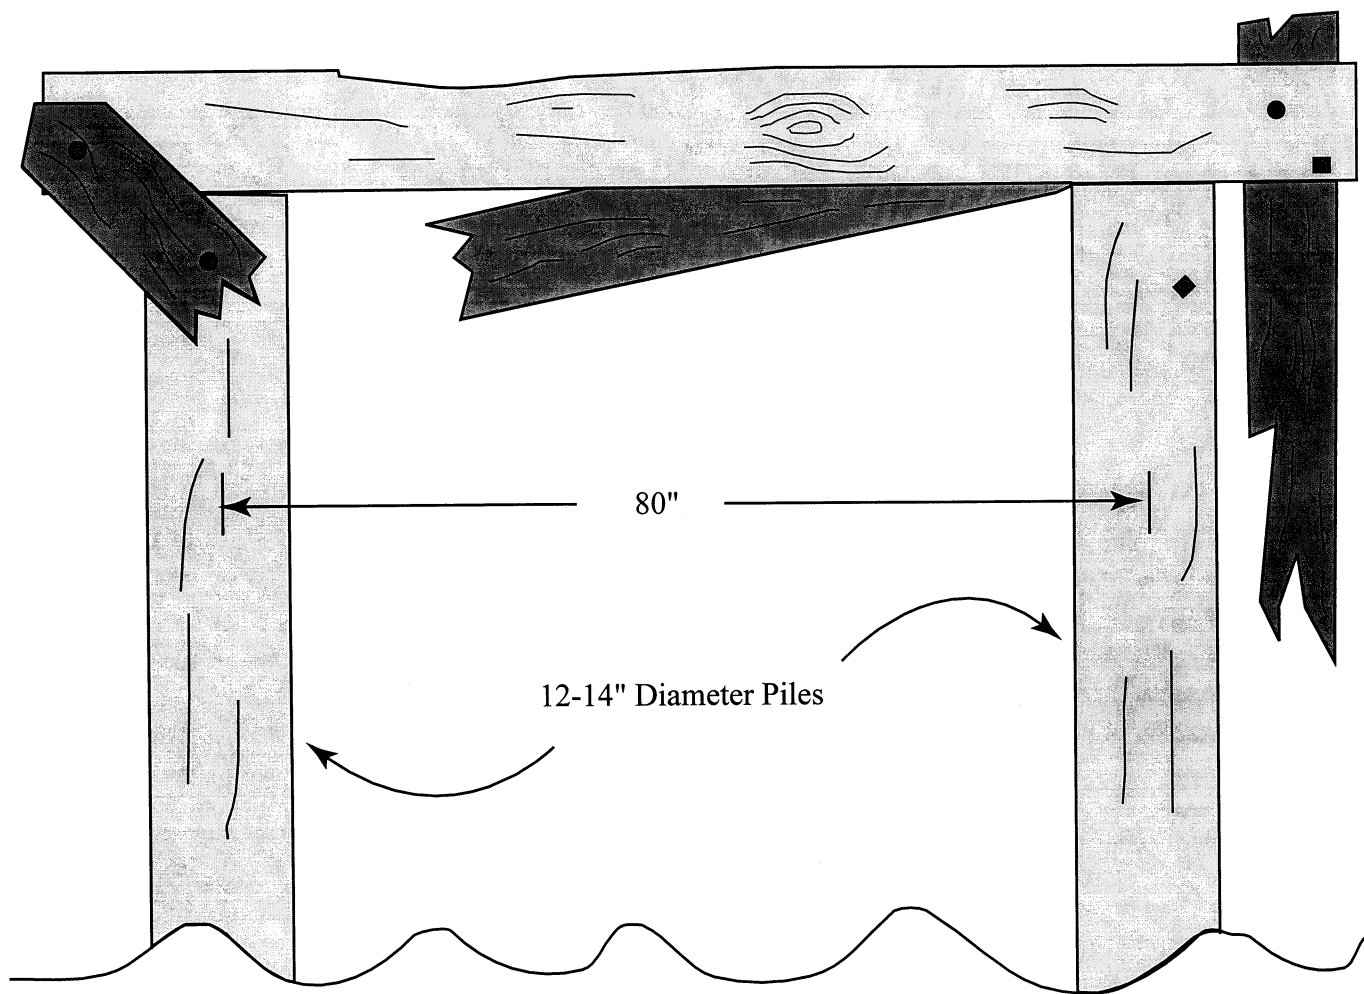
Figure 4
 Carquinez Straits
 Project

Typical Configuration of Pile Set
